G. DUMITRU^{1,✉}V. ROMANO¹Y. GERBIG²H.P. WEBER¹H. HAEFKE²

Femtosecond laser processing of nitride-based thin films to improve their tribological performance

Published online: 9 October 2003 • © Springer-Verlag 2003

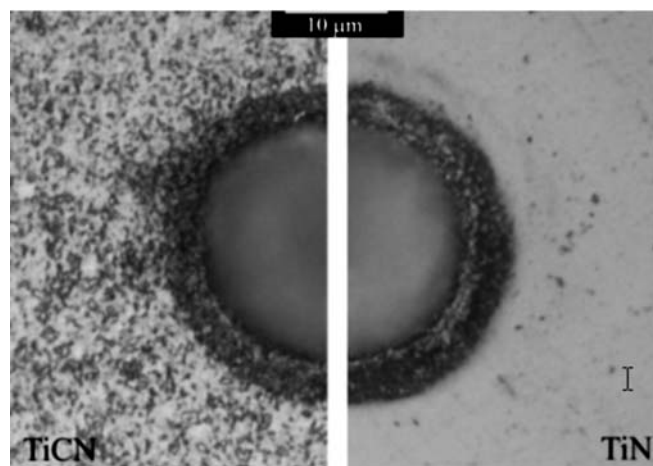
FIGURE 1 Images (optical microscopy) of pores induced in ceramic films ($100 \times 2\text{ J/cm}^2$)

The optical microscopy investigations of the crater boundary zone, where damage due to laser treatment was apt to appear, did not reveal (Fig. 1) any film cracks, delamination, or other surface modifications. These analyses also showed that the remaining surfaces were not affected by the laser treatment; their roughness values did not change and they could be used as tribological surfaces directly after the fs-laser processing.

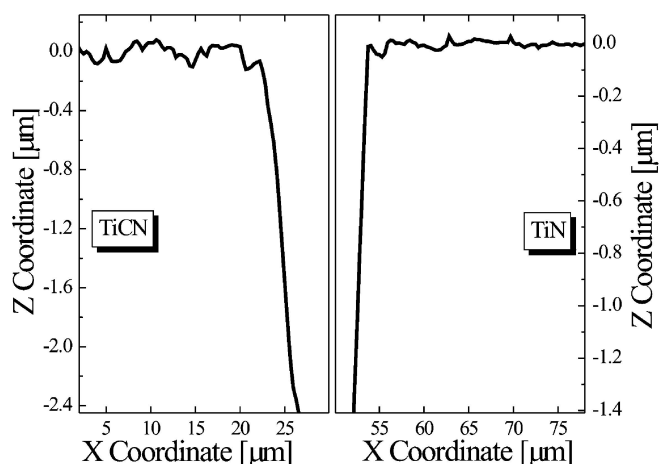
FIGURE 2 AFM profiles along diameters of pores shown in Fig. 1

AFM analyses (Fig. 2) demonstrated a distinct transition between irradiated and non-irradiated film zones, without significant rims at the crater borders. Regarding the transition

zone between the coating and substrate in the case of TiN, ($1\text{ }\mu\text{m}$ thick) smooth pore walls, without any spikes or sharp rims, were noticed. In the case of TiCN, no such points were observed, but in this situation, the film thickness ($3.5\text{--}4\text{ }\mu\text{m}$) was outside the reliability zone for AFM-measured depths.

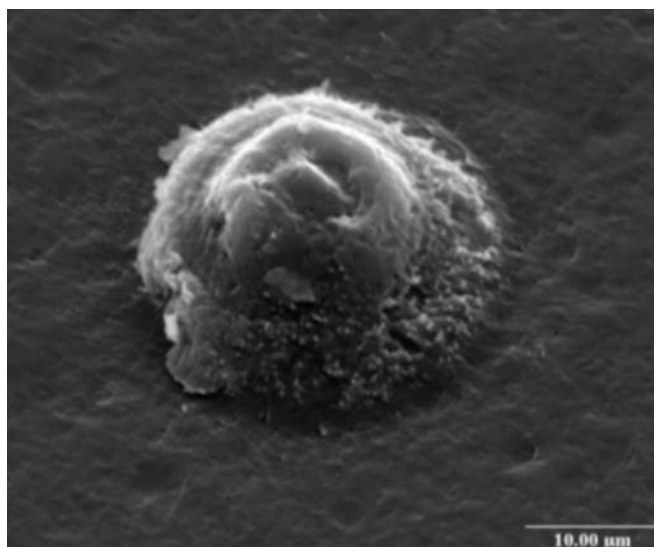
FIGURE 3 Volume representation of a laser-induced pore (TiCN-coated hard metal, $100 \times 2 \text{ J/cm}^2$)

To investigate the actual 3D shape of the laser-induced pores, a replica technique [1] was used to achieve a “negative copy” from microcraters; an SEM image from a replica of a single pore is shown in Fig. 3. Similar shapes were also obtained for pores in the TiN film. Therefore, one can state that the slope change that is noticeable in Fig. 3 is related to laser irradiation factors.

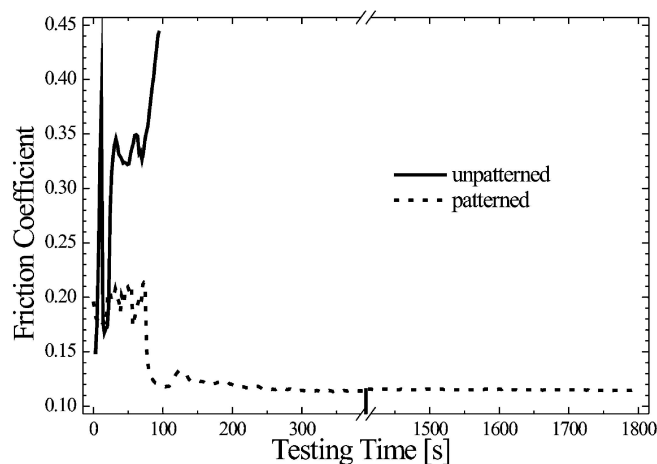
FIGURE 4 Friction curves for laser-patterned and unpatterned TiN-coated surfaces

Typical friction curves for unpatterned and laser-patterned surfaces are depicted in Fig. 4. Significant differences in the friction evolution between the two types of surfaces can be seen. Due to insufficient lubrication of the tribocontact area, the unpatterned surfaces exhibited a continuously increasing friction coefficient that attained the

friction-related stop criterion shortly after the start of the test (100–120 s). In the case of the patterned surfaces, the friction coefficient rose temporarily to values of $\mu \sim 0.2$ in the running-in phase of the tests, but decreased afterwards and remained stable at a level of $\mu \sim 0.11$ until the end of the test; this value is typical for boundary friction [21].

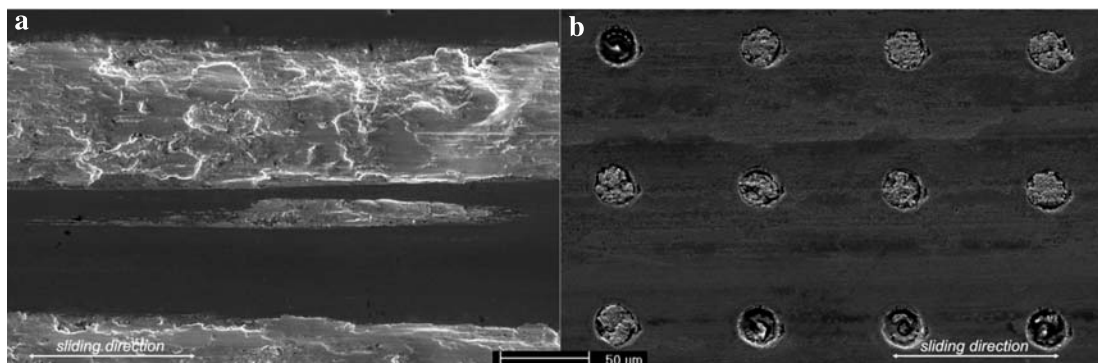
FIGURE 5 SEM images of wear tracks on TiN-coated surfaces: **a** unpatterned and **b** patterned

After tribological testing, SEM and energy dispersive X-ray (EDX) investigations were carried out to study the wear tracks generated on the tested surfaces. Representative close-ups of the worn surface regions on the unpatterned and laser-patterned samples are shown in Fig. 5.

In the case of the laser-patterned surfaces, only slight wear features were noticeable. Noteworthy is the fact that a large part of the pores situated in the wear track were filled to

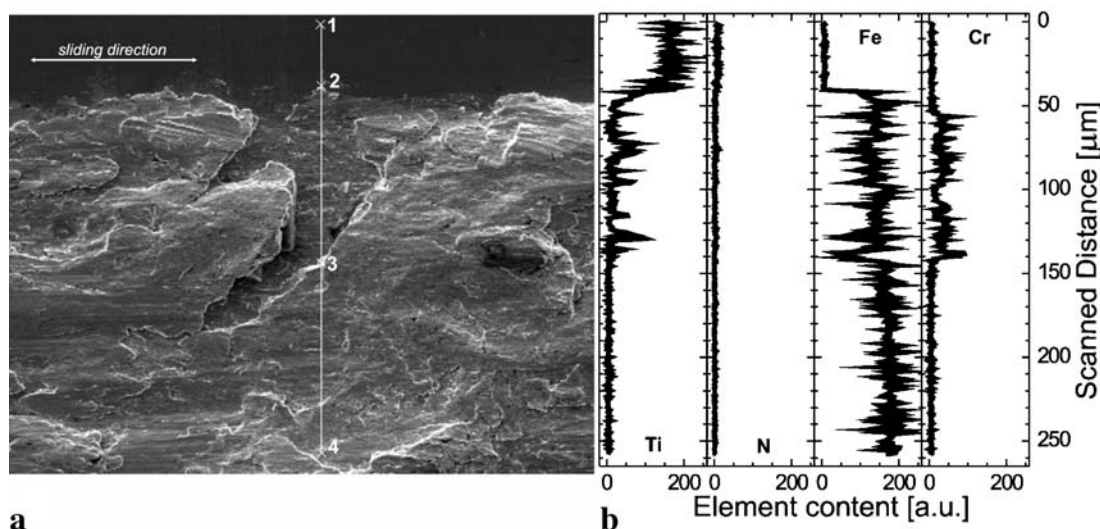
FIGURE 6 Detail from a wear track on a TiN-coated and unpatterned surface: **a** SEM image and **b** EDX analysis of elemental content along the white line marked in **a**

To determine the exact nature of the stripe-shaped wear features observed on the unpatterned TiN surface, EDX line scans were performed (Fig. 6). The presence of the chemical elements Fe, Cr, and Ti was proven along a line running from a less worn region to a damaged zone (Ti: protective film, Cr: substrate of coated sample, Fe: substrate of coated sample and counter body).

Along the EDX line scan from points 1 to 4 in Fig. 6, the following features are observed: (i) the Ti content remains constant (150 counts/s) between points 1 and 2; at point 2, the content drops suddenly down to 0 and remains at this value until point 4 is reached; (ii) the Cr concentra-

tion is 0 between points 1 and 2; at point 2, the concentration increases to about 40 counts/s and oscillates around this value until point 3 is passed; between points 3 and 4, the Cr concentration decreases to zero; (iii) there is no detectable Fe signal between points 1 and 2; at point 2, an Fe signal appears suddenly and rises from 150 to 200 counts/s at point 4.

If one considers that the substrate of the coated disk is steel with a high Cr content, but that the counter body is made of non-alloyed steel, an interpretation of these results is that a large number of solid–solid contacts were generated between the sample and counter body, which led to damage and finally to local removal of the coating from the substrate. The contact between the exposed steel substrate (uncoated sample) and the steel counter body sustains excessive material transfer from the counter body to the sample due to adhesive wear processes.

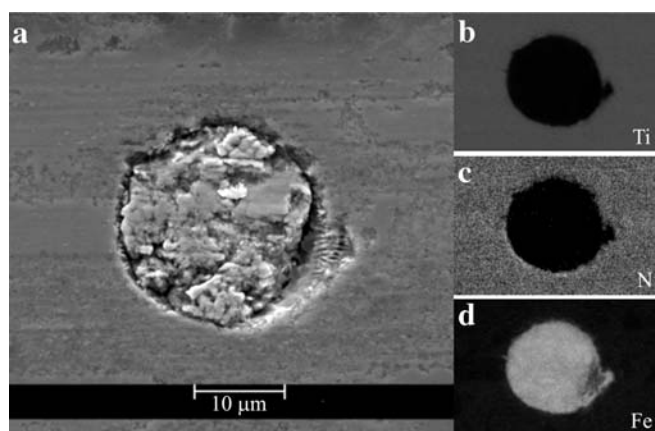
FIGURE 7 Detail from a wear track on a TiN-coated and laser-patterned surface: **a** SEM image of a filled pore and **b–d** EDX mappings for various elements

varying degrees with debris. An SEM image of an almost completely filled pore and its vicinity is shown in Fig. 7. The spatial distribution of the chemical elements Ti, N, and Fe (Ti, N: protective film, Fe: counter body) in the depicted zone was determined through EDX mapping, with a lateral resolution of 0.2 μm . The number of counts indicating the presence of a certain element was converted into gray levels and distribution maps were constructed; they are also depicted in Fig. 7. From these images, one can see the uniform and continuous presence of Ti and N in the pore surroundings and the almost complete absence of Fe from this zone. On the other hand, inside the pore a quasi-total absence of Ti and N and a large Fe amount were detected. These results indicate an unbroken TiN film in the pore surroundings and a large accumulation of debris coming from the counter body in the laser-induced microcraters.
